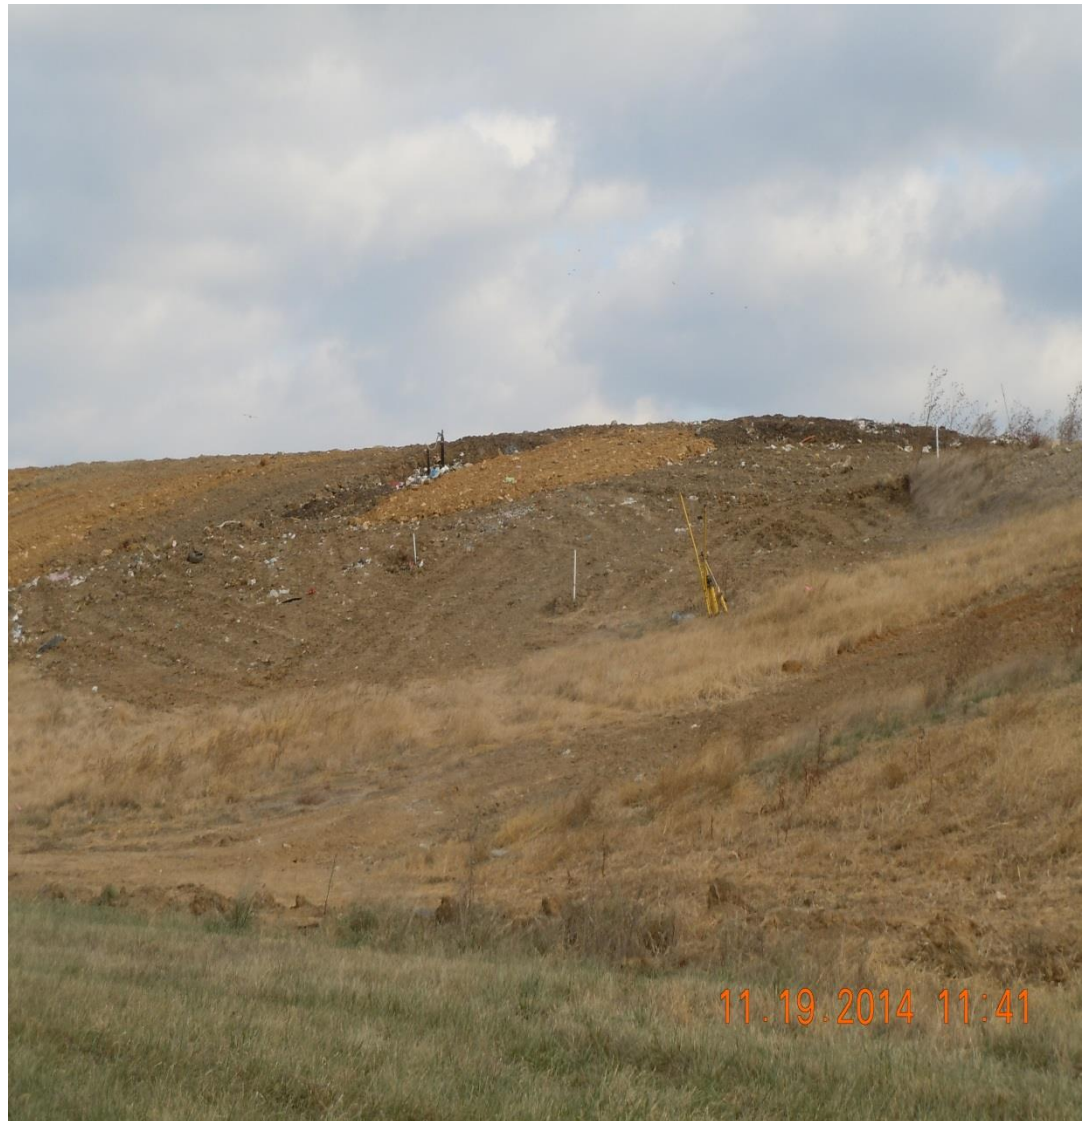
Cover

The cover shown in this photo warrants additional information to be obtained from the landfill representative. This should be shown as unsatisfactory on the inspection checklist with a comment on the lower portion. This would not warrant a Letter of Warning or a Notice of Violation to the facility, but would require additional action to be taken to address the unsatisfactory feature.

Several factors may contribute to waste being visible during an inspection. Those most encountered include insufficient cover application, waste exposed by erosion after weather event (heavy rain, large snow melt, etc.), waste tracked from the working face on equipment, wind blown litter or gas well maintenance.

Note: This can be expected at any landfill from time to time. In excessive situations, the landfill can address exposed waste by either applying additional cover soil or hand picking the waste from the slope.

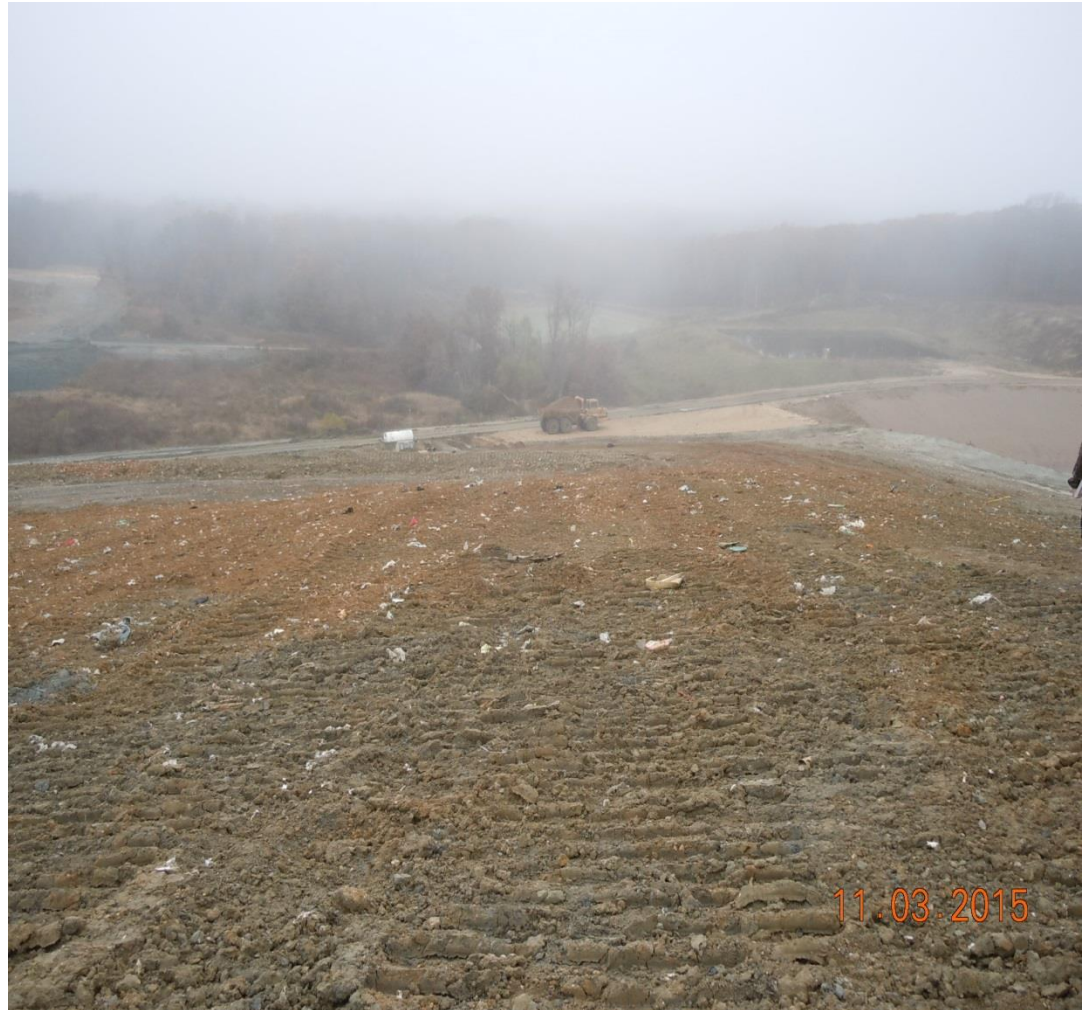
Cover (cont.)

The waste in this photo at first glance does not appear to be excessive. This slope has reached intermediate status (will remain idle for 60 days or more). Outside slopes are designed to drain directly to the storm water system. This waste will likely migrate from the slope and enter the storm water. Waste coming into contact with storm water creates two problems. First, according to the Solid Waste regulations, any water coming into contact with waste at a landfill is considered leachate and must be managed as such. Second, waste entering into storm water is a violation of the Missouri Clean Water Law.

This facility would be required to either remove the waste from the slope or cover the exposed waste to prevent additional violations.

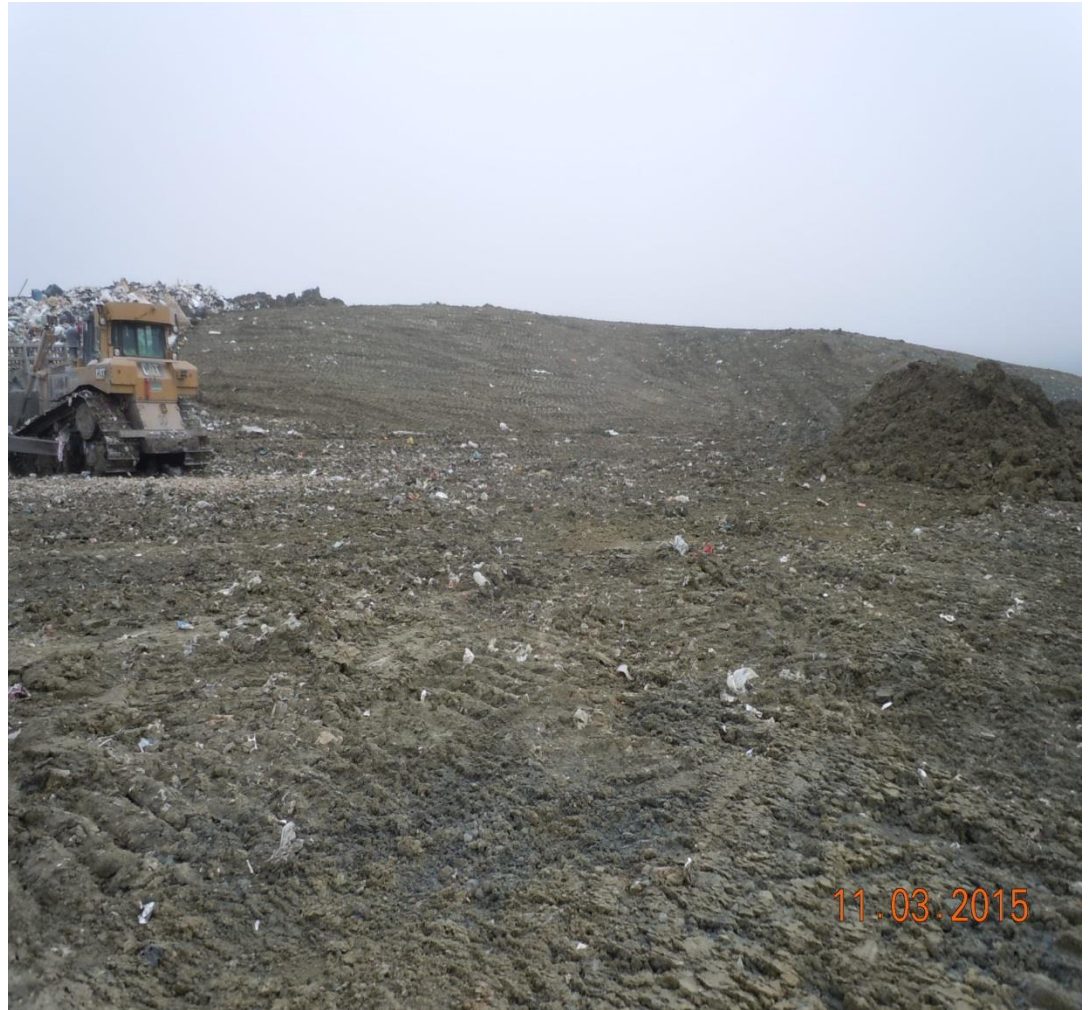
Cover (cont.)

The cover shown in this photo contains waste that was likely tracked with the equipment visible to the left (also visible is a portion of the active working face). The facility would not be required to add additional cover soil immediately in this area because it is on an inside slope, which means the waste cannot migrate off site. Additionally, this area is located near the active working face of the landfill and will likely receive additional traffic by the end of the work week. It would be appropriate for the inspector to request the facility to add a small amount of cover at the end of the week when the facility closes.

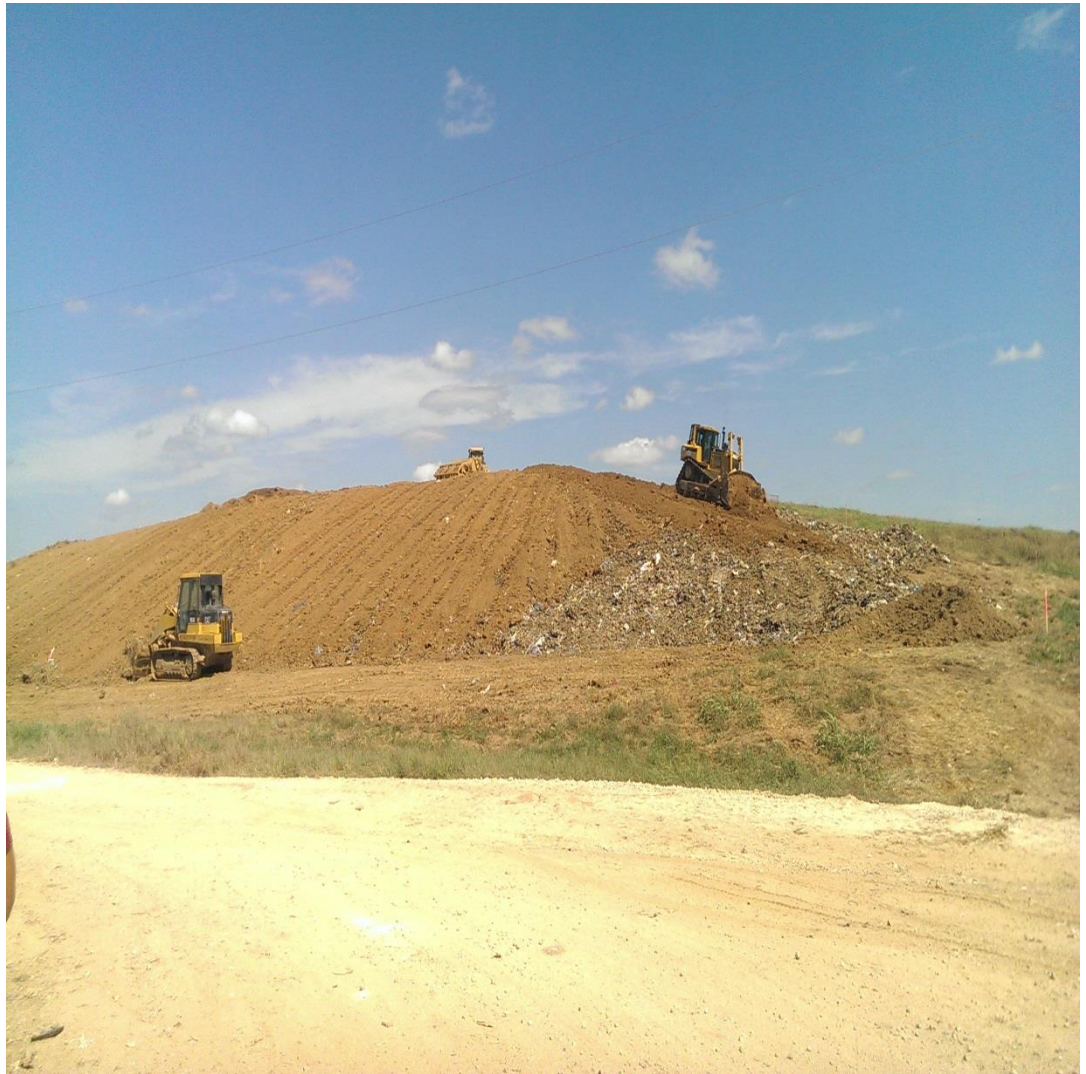
Cover (cont.)

The photo shown to the right is an excellent comparison photo between unsatisfactory due to visible waste (lower right portion of slope) vs. satisfactory cover with little to no visible waste (left, fresh covered slope).
